# MERIAM HOUSE

Minute Man National Historical Park  
Concord, Massachusetts

## Historic Structure Report

Barbara A. Yocum, Architectural Conservator  
Historic Architecture Program, Northeast Region  
National Park Service  
Lowell, Massachusetts

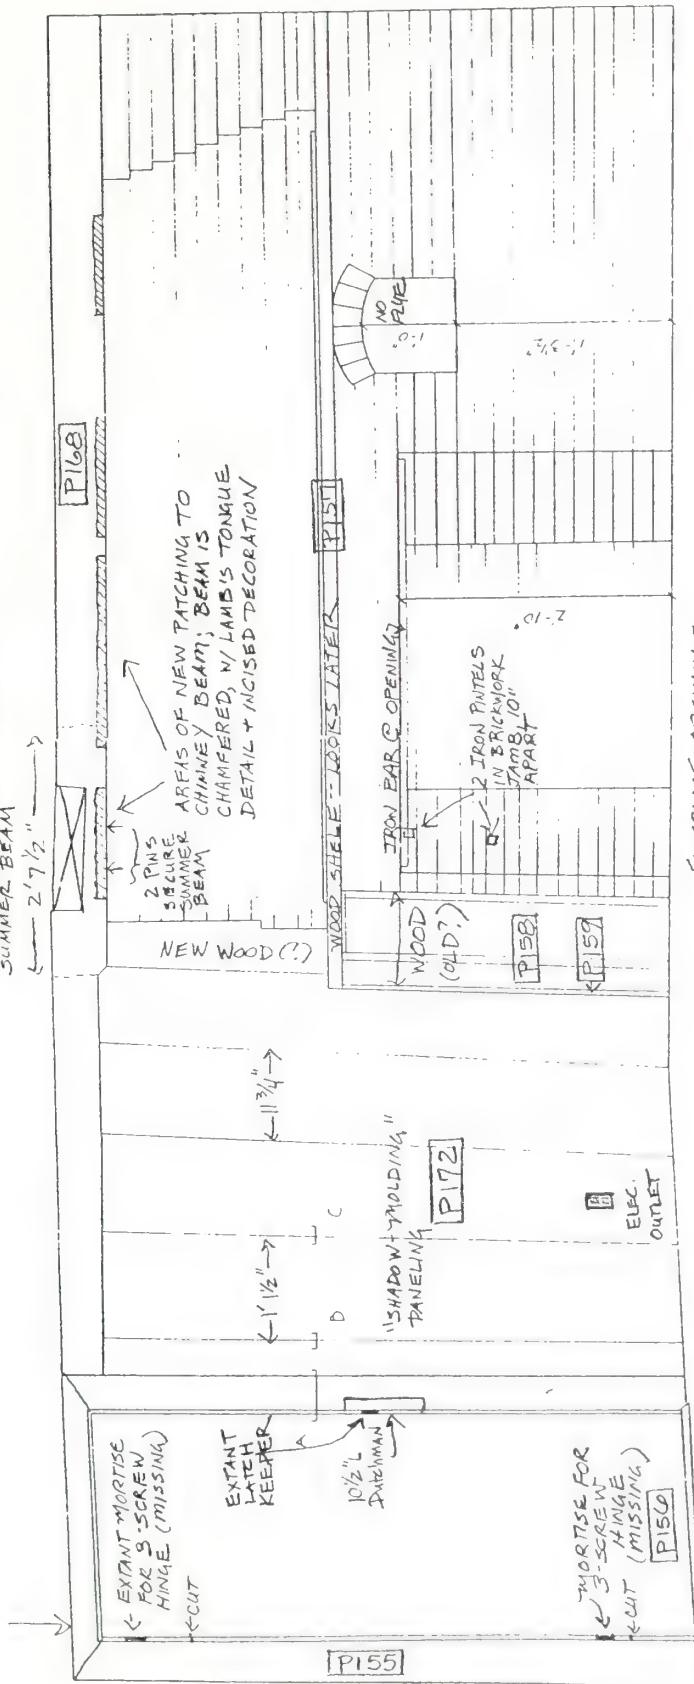
DOORWAY OPENING:  
 $2' 4\frac{1}{2}" \times 6' 4" \times 11"$  DEEP  
 FORMER DOOR:  $\approx 2' 5" \times 6' 2" \times 11"$

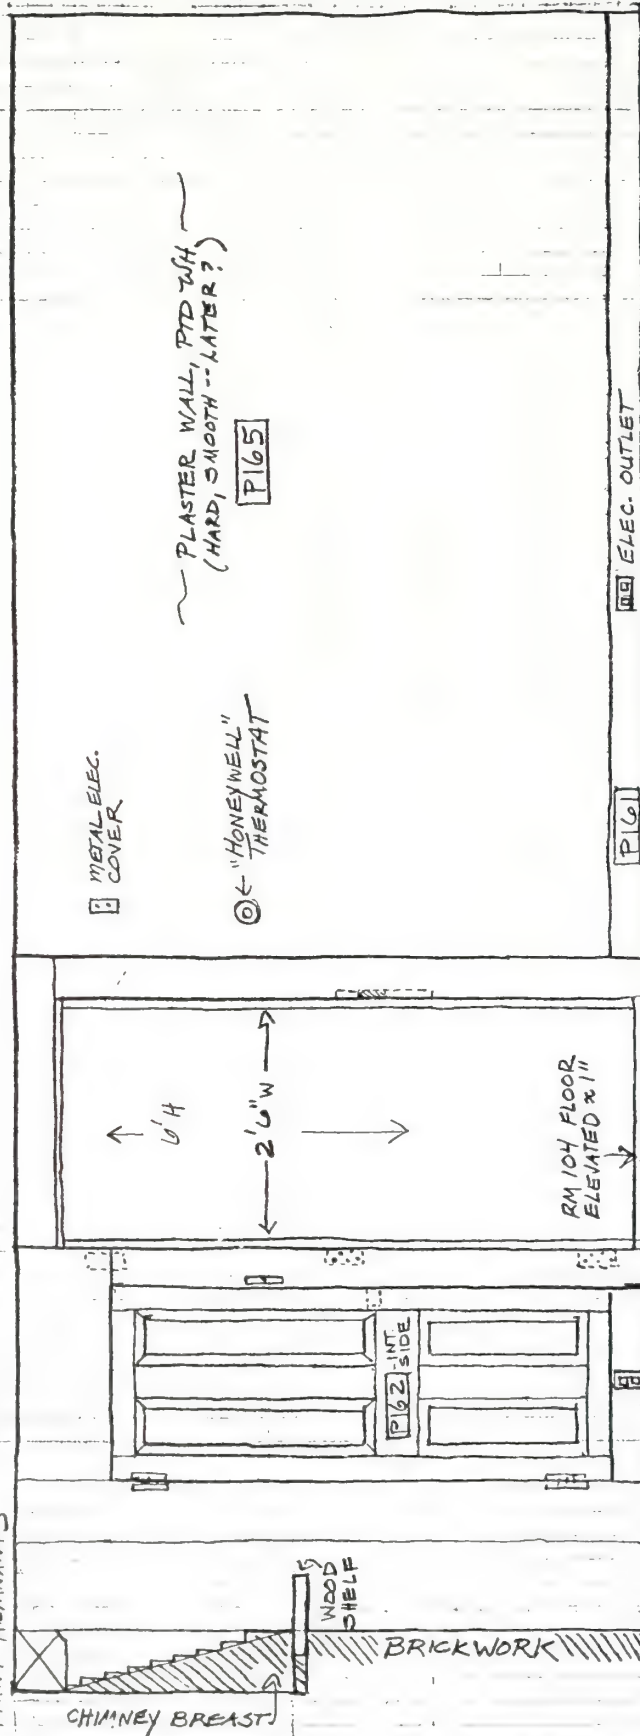
DOORWAY TO RM 104:  
NO DOOR TODAY; HOLES ON  
W SIDE OF 3 HINGES FORMERLY  
(5 SCREWS EA.); ON E SIDE,  
12" L DUTCHMAN W/ HOLES  
MOST RECENT LATCH. PATCHED  
HOLES W SIDE OF POSSIBLY  
X2 EARLIER HINGES (H TYPE?)  
FORMER DOOR MEASURED ~ 2'7 1/2" W x 6'1" C->

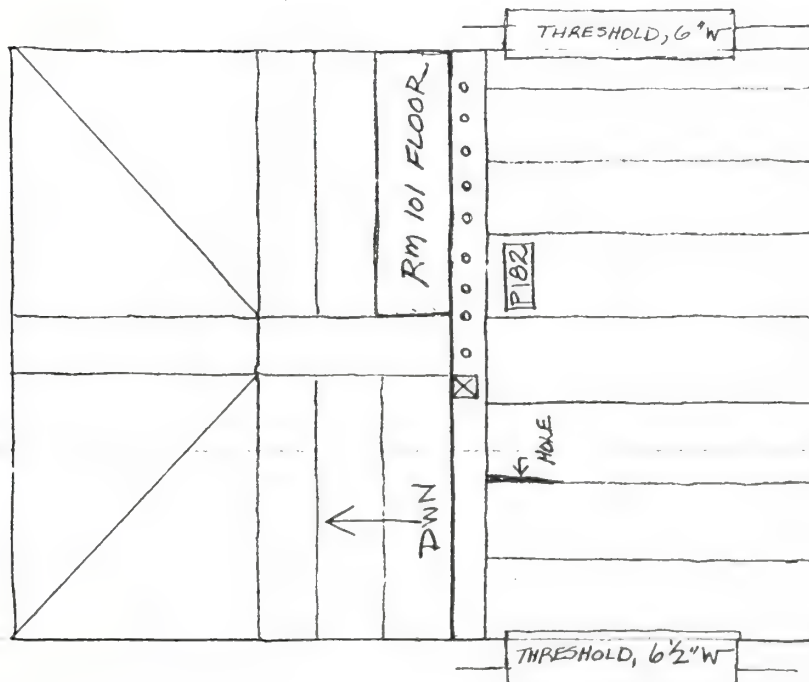
FLOOR

FLOORBOARDS: HAVE BEEN SANDED;  
ORIGINAL 7 SOME REMNANTS  
OF YELLOW PAINT; NAILS APPEAR  
TO BE CUT; WIDE GAPS BETW.  
BOARDS; WIDTH =  $9\frac{1}{2}$  -  $10\frac{1}{2}$ ";  
EXTANT FINISH = WORN VARNISH

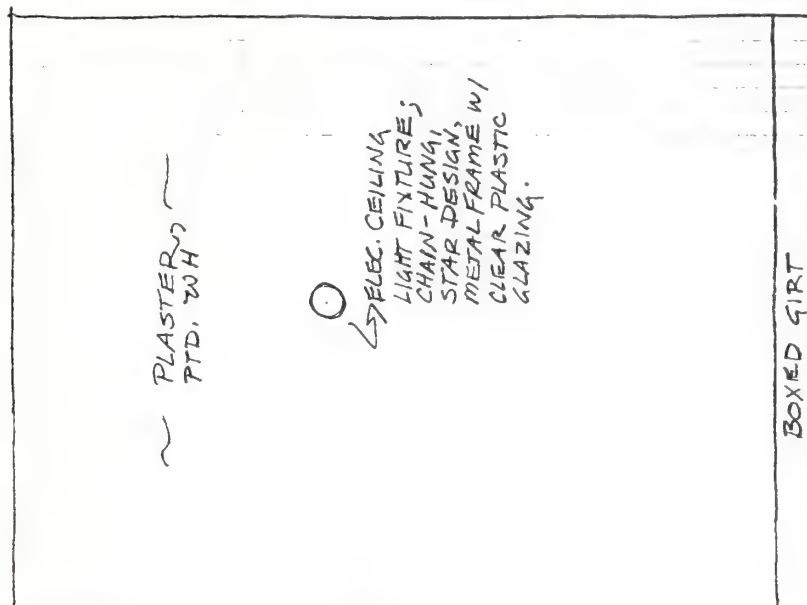
PLASTER: ON WOOD LATH; IN ATTIC CAN  
SEE REUSED BASEBOARD THAT WAS  
USED AS A NAILER FOR THE PASTER  
CEILING (AFTER THE ATTIC STAIRWAY  
WAS REMOVED)

One furring board for the lath was observed to be a length of reused baseboard, 7 inches high, with a top bead detail. (It is attached to the side of a joist near the chimney.) A small sample of wood was extracted from the board for microscopic analysis, but no paint finishes were found.

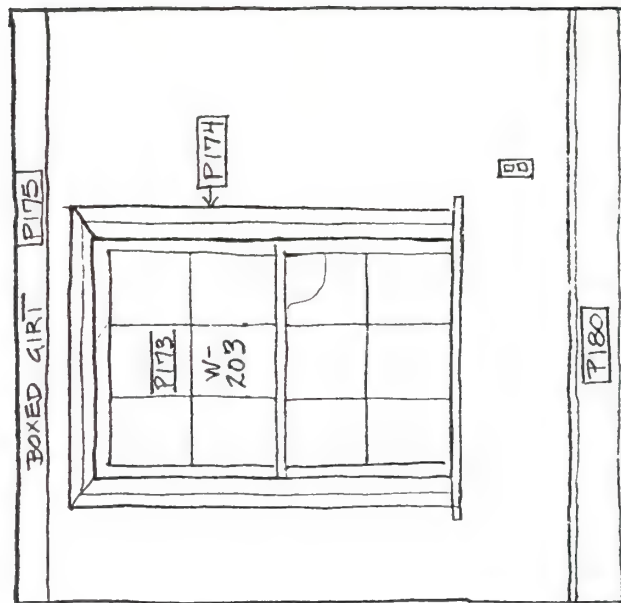
WINDOW: 6/6 SASH; ARCHITRAVE  
MOLDING IS SAME PROFILE  
AS IN ADJACENT FRONT BEDROOMS (↑  
FRONT ROOMS DOWNSTAIRS)

WALL: PLASTER, LOOKS OLD

One window (W-203) in the south wall provides natural lighting to the stair hall and stairway. The opening may be original; the existing woodwork dates to circa 1820, except for the six-over-six sashes that replaced similar sashes circa 1925.

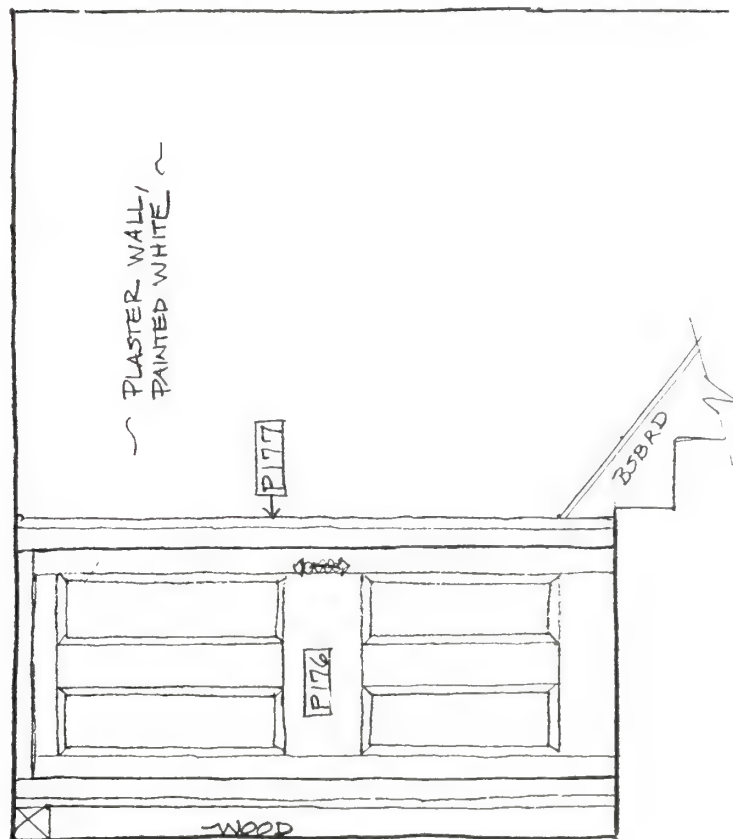
MIMA: MERIAM HS  
RM 201, WEST WALL  
SEPT. 7, 1993; B. Yocum  
SCALE: 1/2" = 1'0"

DOOR: MORTISED, WITH NORFOLK LATCH  
("NAVY" BACKPLATE) 4 X 2 HINGES  
(3-KNUCKLE, 3 SCREWS/LEAF); PANELS  
ARE RAISED RM 201 SIDE, RECESSED-MOLDED  
RM 202 SIDE; DOOR MEASURES: 2' 5 3/4" W  
6' 2 1/8" H  
1" THK  
APPEARS TO BE IN ORIG. LOCATION.

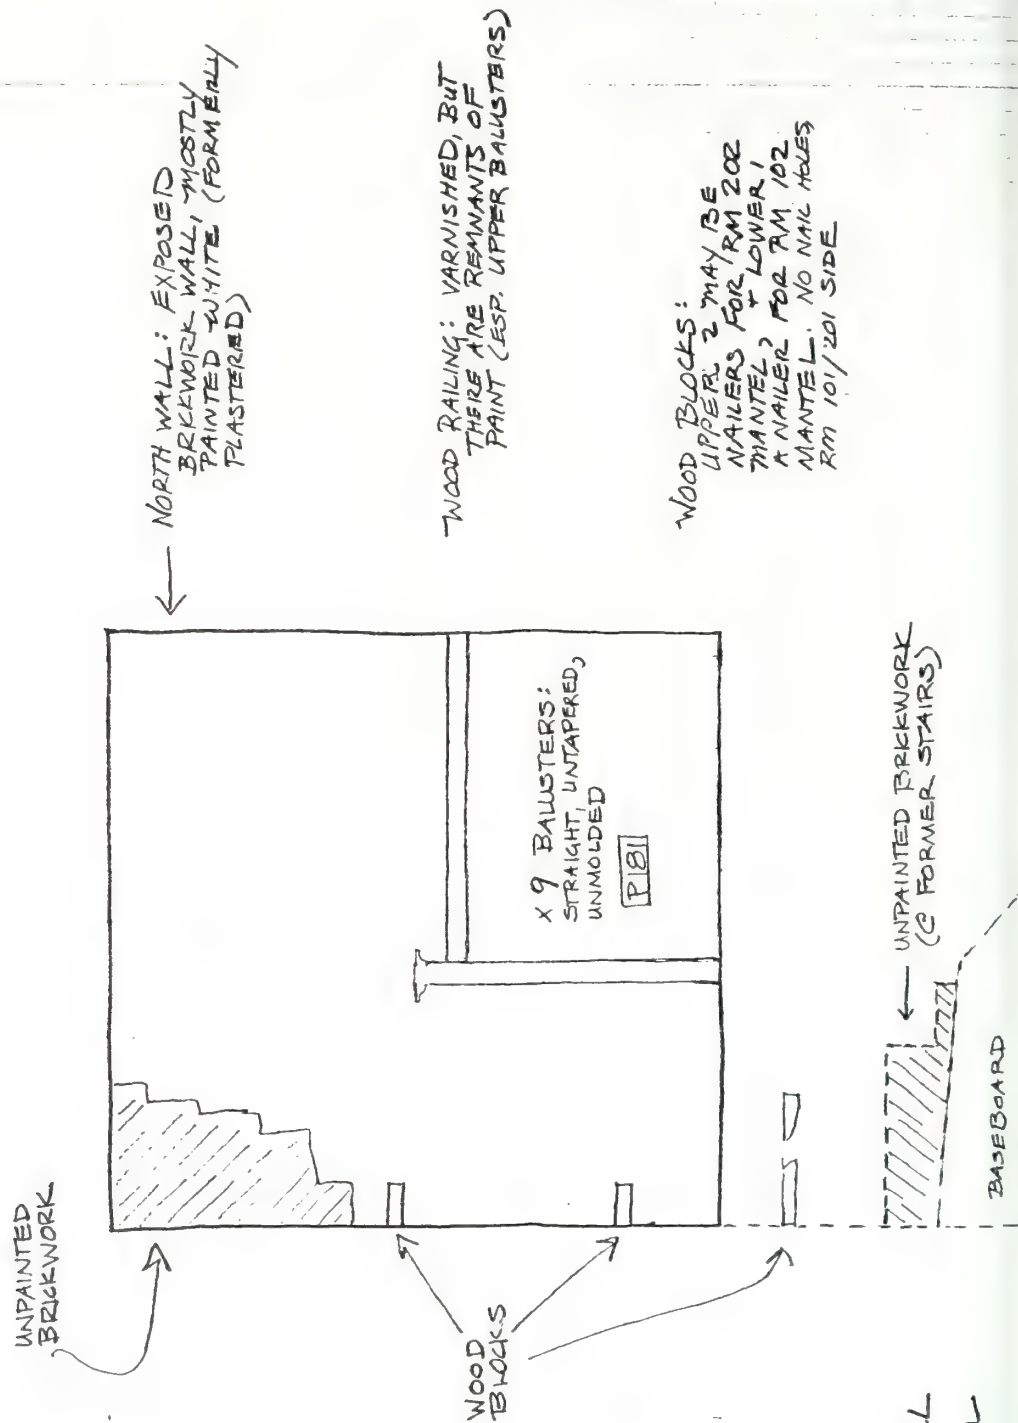
MIMA: MERIAM HS  
RM 201, NORTH WALL  
SEPT 7, 1993; B. Jochum

NOTE: EXISTING SUFFOLK  
LATCH IS MODERN

ARCHITRAVE MOLDING SAME  
AS WEST DOORWAY (NOTE:  
PROFILE DIFFERS FROM  
WINDOW ARCHITRAVE)

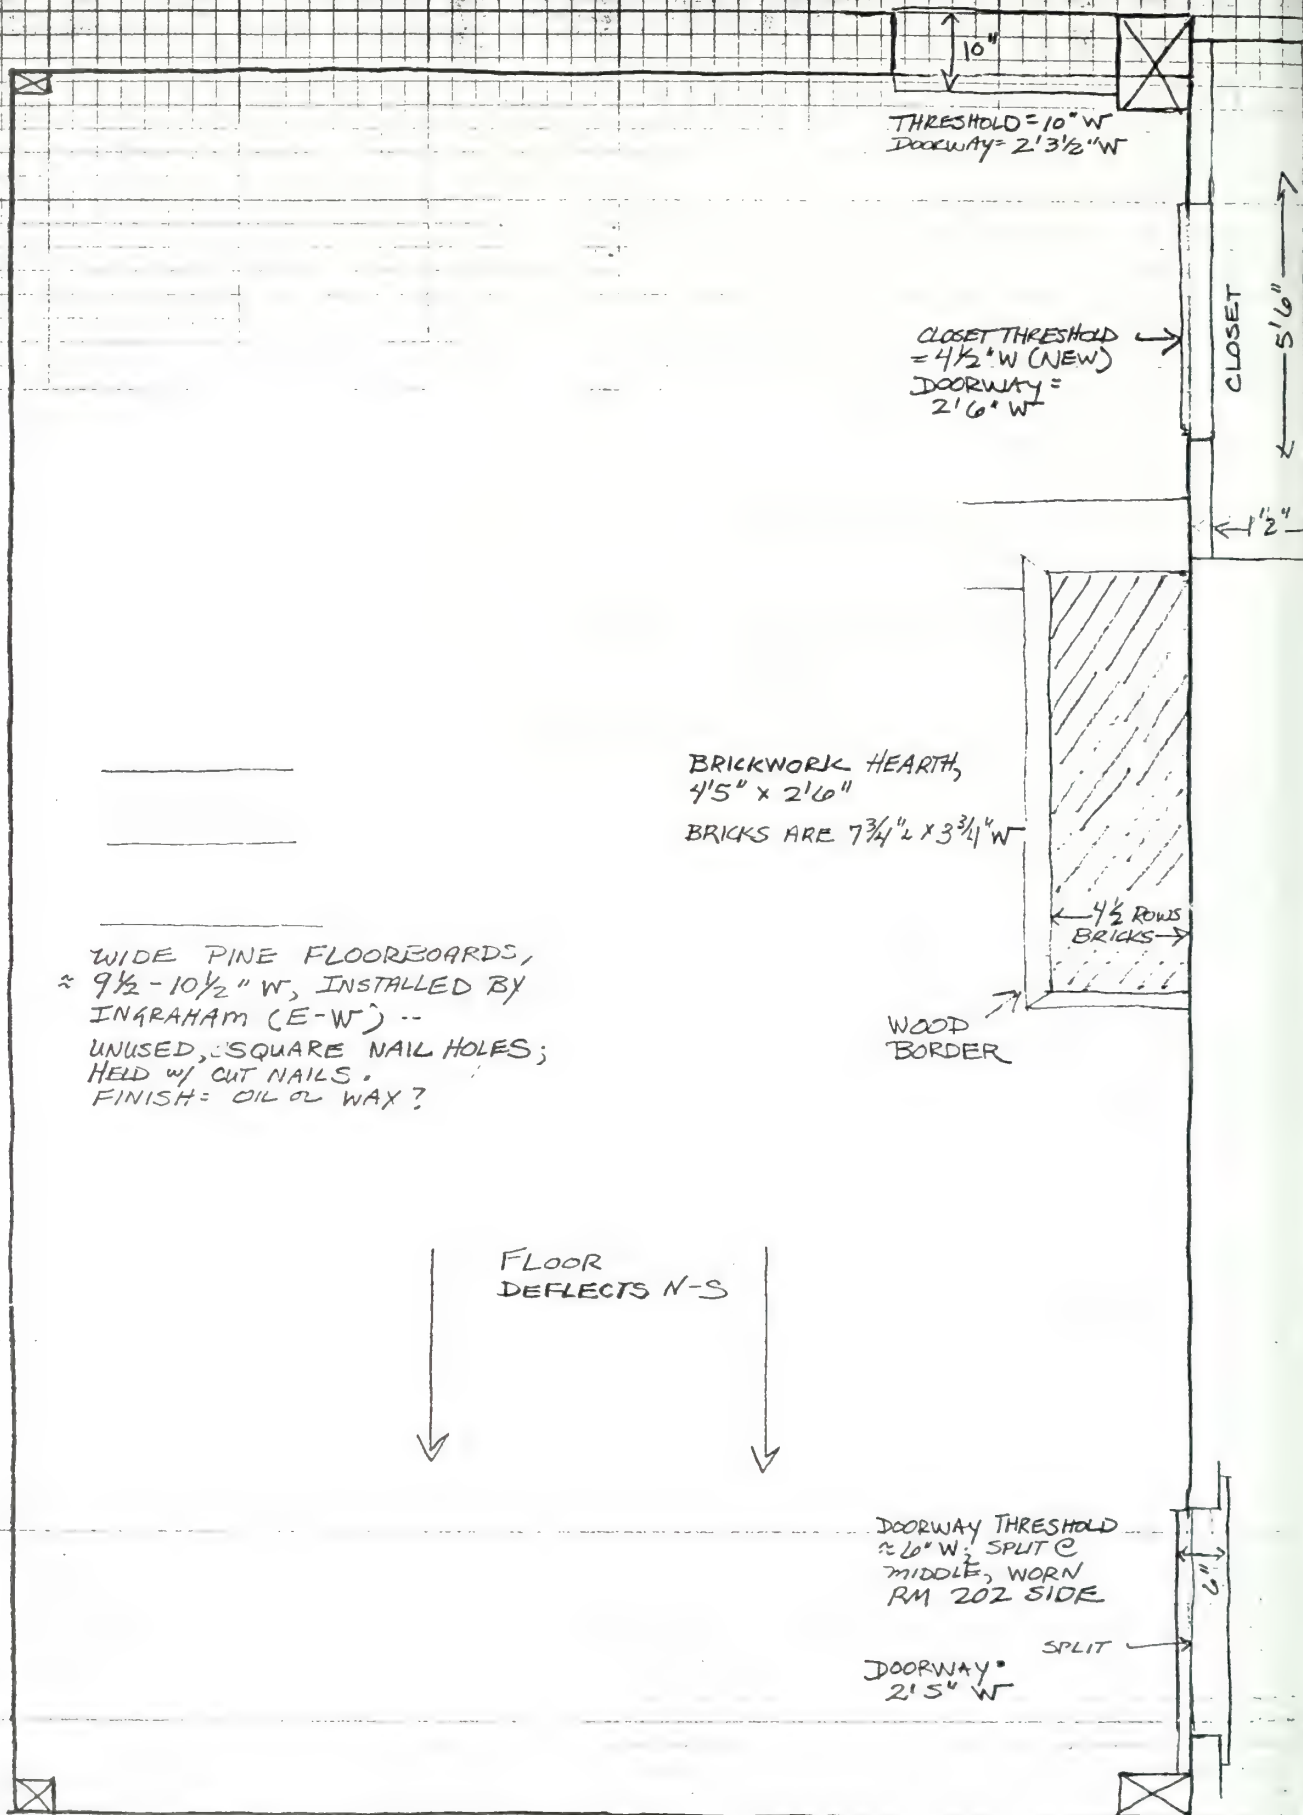
RM 202, FLOOR

FINISHES: PLASTER = WHITE (SAND-) PAINT;  
 WOODWORK = BLACK PAINT  
 RADIATOR = SILVER

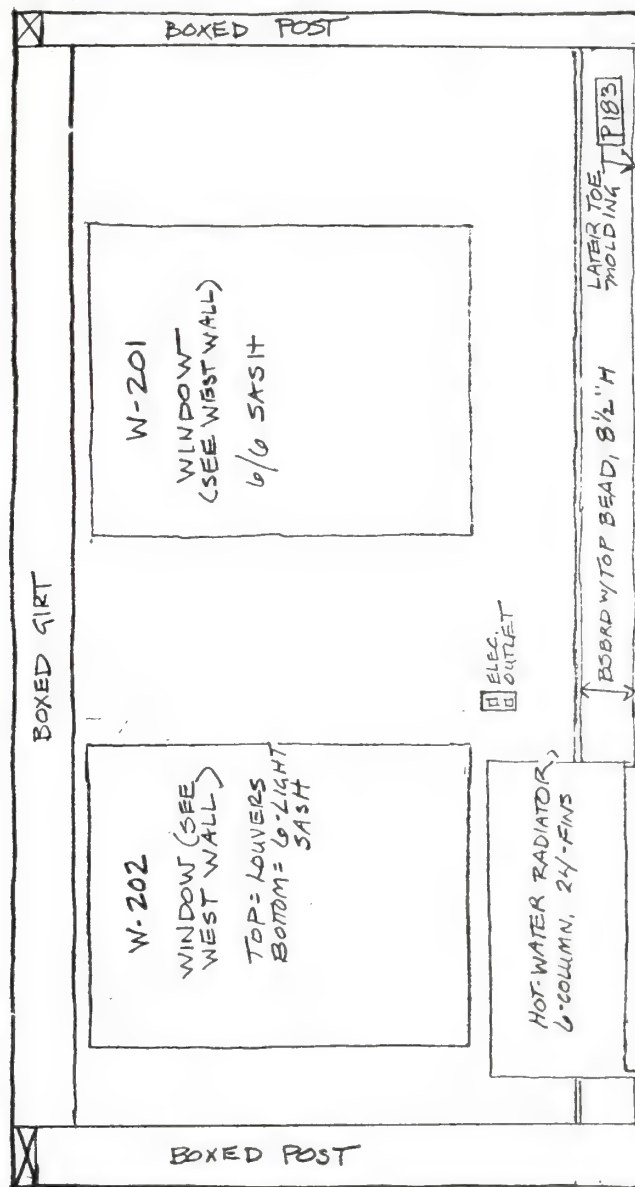
THMA: MERIAM HS  
 RM 202, SOUTH WALL  
 SEPT 9, 1993; B. YOUNG  
 SCALE: 1/2" = 1'0"

FINISHES: WALL PAINTED WHITE; ALL WOODWORK  
PAINTED BLACK

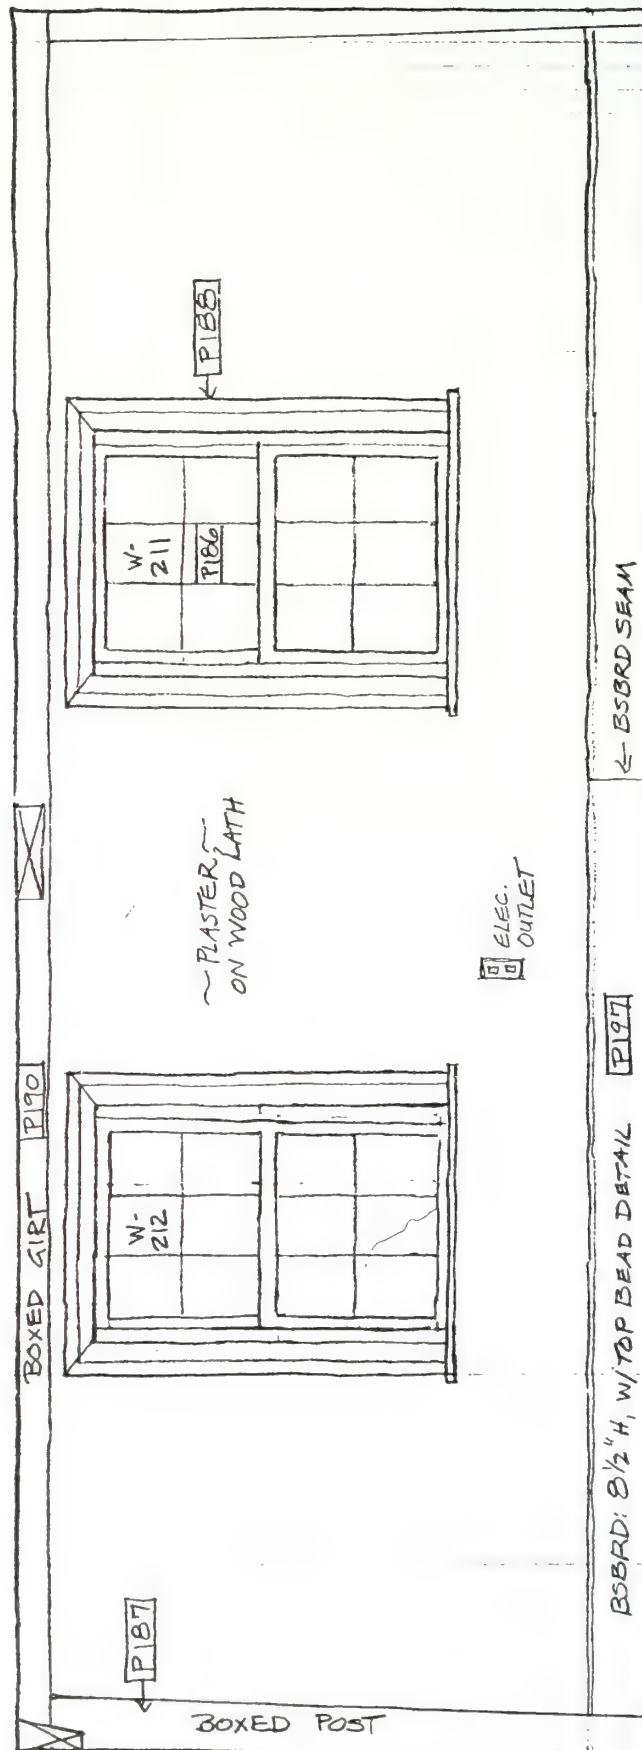
MIMA: MERIAM HS  
RM 202, WEST WALL  
SEPT. 7, 1993; B. YOUNG

DOOR: OLD, OF MORTISED CONSTRUCTION;  
ARCHITRAVE IS ALSO OLD (= EAST  
DOORWAY). NORFOLK LATCH SAME  
STYLE AS @ EAST DOOR. DOOR  
HAS BEEN ENLARGED W/ 3/4" SHIM ON  
EAST SIDE. HINGES ALSO SAME  
AS @ EAST DOORWAY. RAISED  
PANELS, RM 202 SIDE; UNMOLDED  
RECESSED PANELS, RM. 203 SIDE.  
DOOR MEASURES:

2' 4 1/2" W (w/SHIM) X  
5' 11" H X  
1" THK

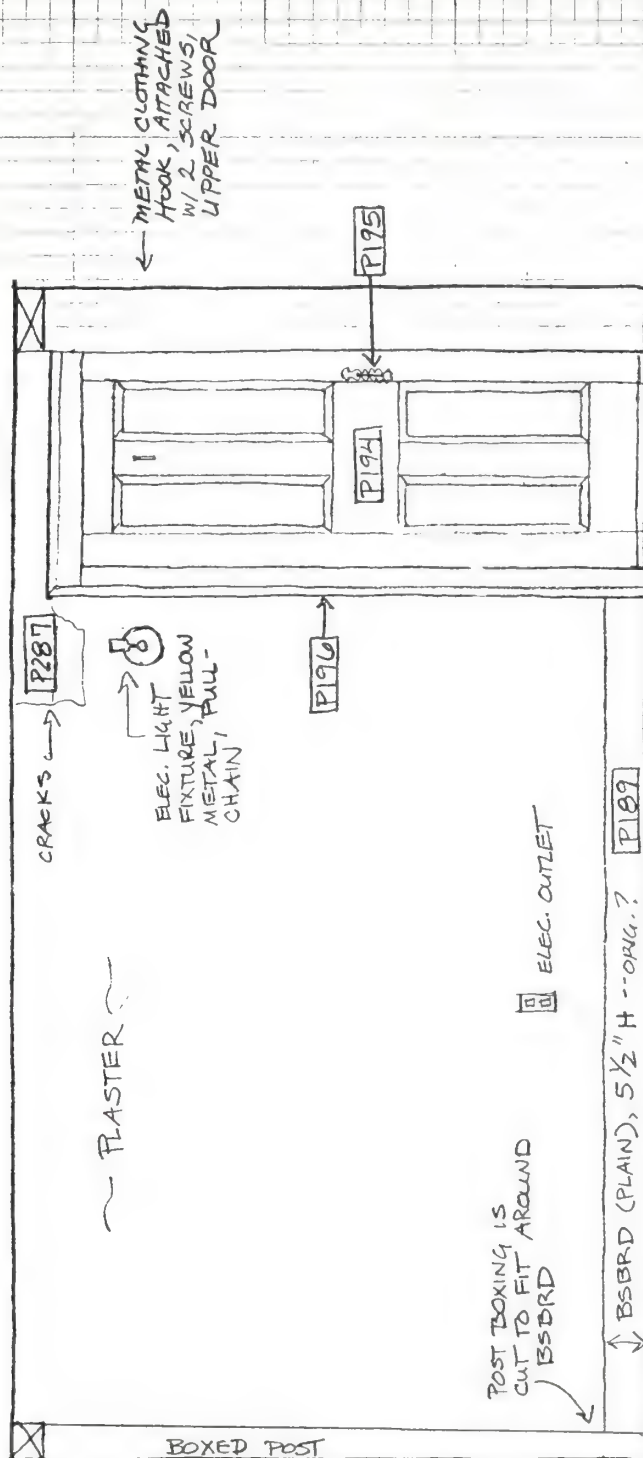
MIMA: MERIATH HS  
RM 202, NORTH WALL  
SEPT. 9, 1993; B. Yocum  
SCALE: 1/2" = 1'0"

CLOSET: INT. IS COMPLETELY MODERN,  
INCLUDING 3 1/4" W PINE FLOORBDS.  
6 3/4" H BSRD (TOP BEVELED), WOOD  
SHELF, X 2 PIPE POLES (E-W) +  
WIRE CLOTHING HOOKS. FINISHES:  
PL WALLS + CEILING UNPAINTED; WOOD  
FLOORBDS UNPAINTED; WOOD DOOR  
INT., BSRD + SHELF (+ APRON) PTD.  
MUST. YELLOW.

FINISHES: PLASTER WALL  
PAINTED WHITE (SAND  
PAINT), WOODWORK  
PAINTED BLACK

DOOR: MORTISED, WITH MOLDDED,  
RECESSED PANELS. SEE  
RM 201 FOR DETAILS

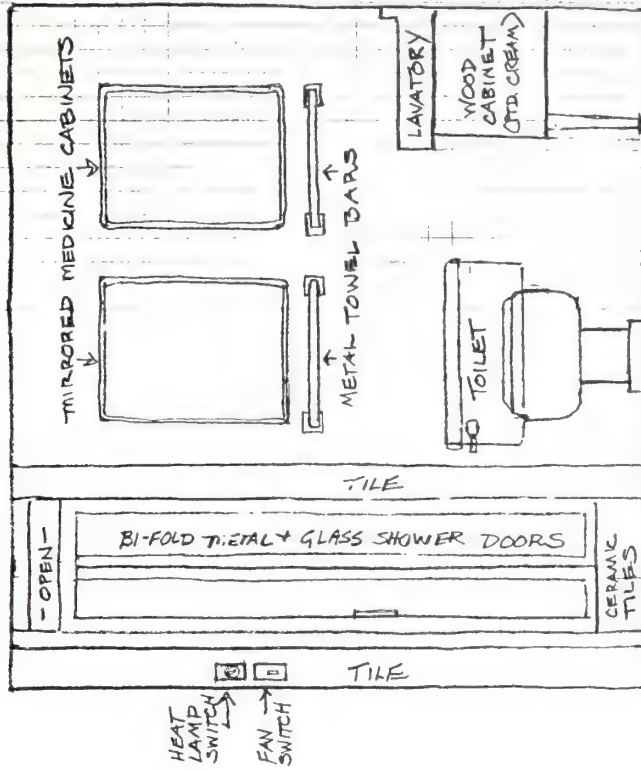
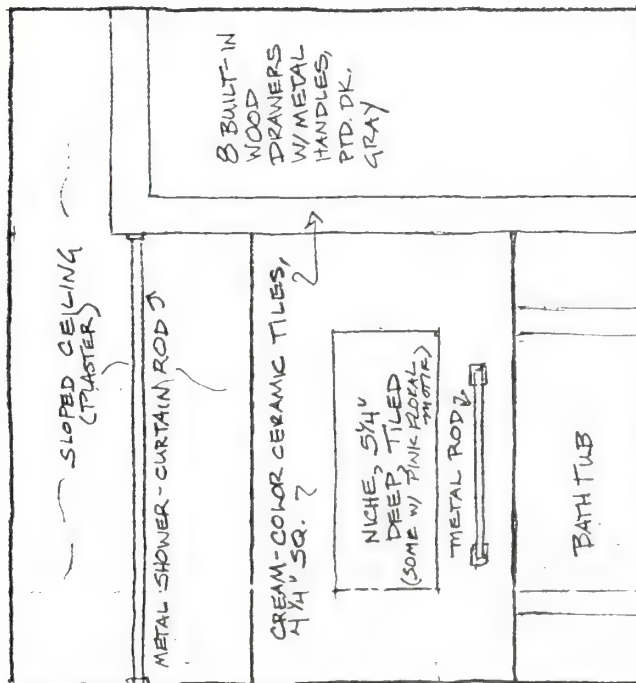
TRIMA: MERIAM HS  
RM. 203, NORTH & SOUTH WALLS  
SEPT. 22, 1993; B. Yocum  
SCALE:  $\frac{1}{2}" = 1'0"$

WALL IS FINISHED WITH CREAM-COLOR CERAMIC TILE,  $4\frac{1}{4}"$  SQ. (ALSO SHOWER ENCLOSURE)

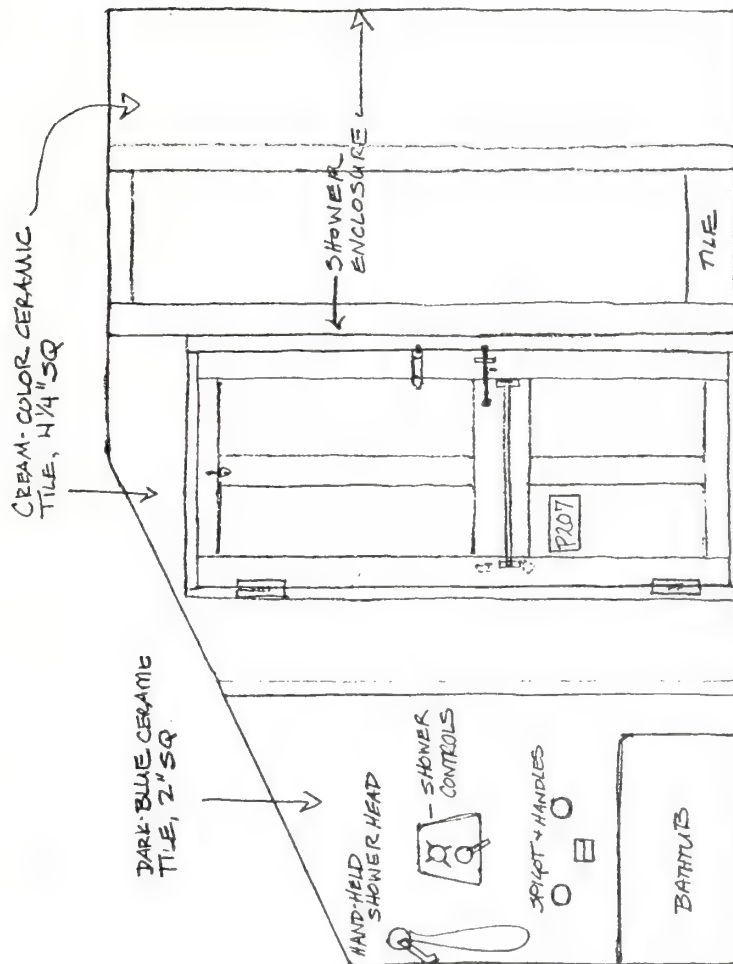
M/M/A: MERIAM HS.  
 RM 203, EAST WALL  
 SEPT. 22, 1993; B.YOCUM  
 SCALE: 1/2" = 1'0"

DOORWAY: TO HALL; SLIGHTLY  
 RECESSED PANELS B.R.  
 SIDING RABED PANELS HALL  
 SIDE; MORTISED; PLUGGED  
 HOLE ON N SIDE WHERE EVIDENCE  
 LATCH WAS & SHADOW EVIDENCE  
 ON HALL SIDE (SO.) OF FOREER  
 L-SHAPED HINGES; EXISTING  
 SUFFOLK LATCH & HINGES ARE  
 REPRODUCTIONS; NO ARCHITRAVE;  
 METAL TOWEL BAR & CLOTHES  
 HOOK ARE ATTACHED TO B.R.  
 SIDE -- ALSO REPRO. DEAD  
 BOLT. DOOR (CUT DOWN) MEASURES:  
 2' 6" W X 5' 8" 1/2 H X 7/8" THK.  
 DOOR HAS BEEN CUT  
 DOWN @ TOP.

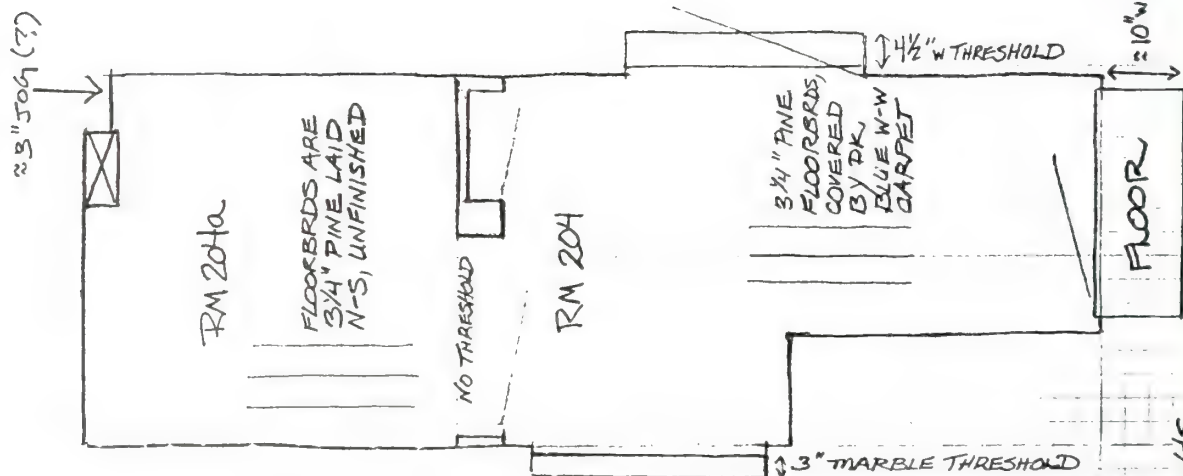
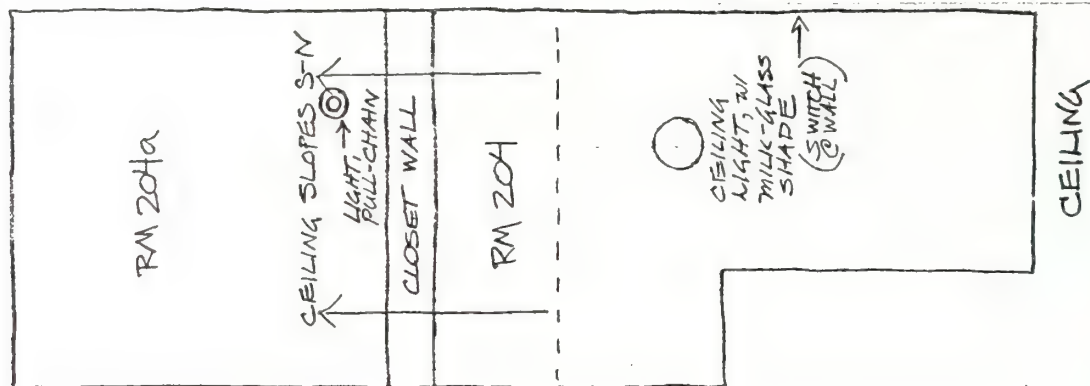
MIMI: MERIAM HS.  
RMS 204 + 204a

CEILING: BOTH  
RMS 204 +  
204a, HARD  
WHITE PLASTER  
(MODERN)

PLASTER WALL (EAST)  
COVERS PTD. ARCHITRAVE, I.  
LATER?

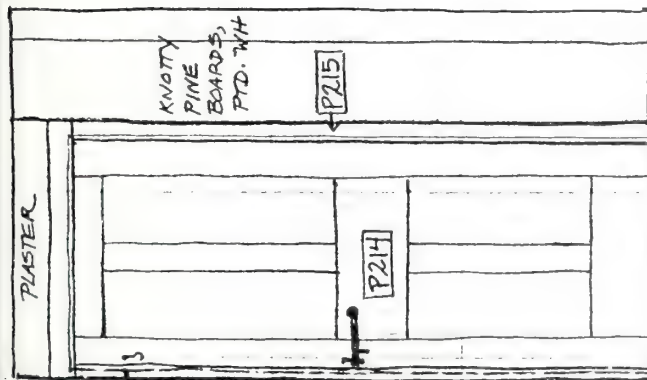
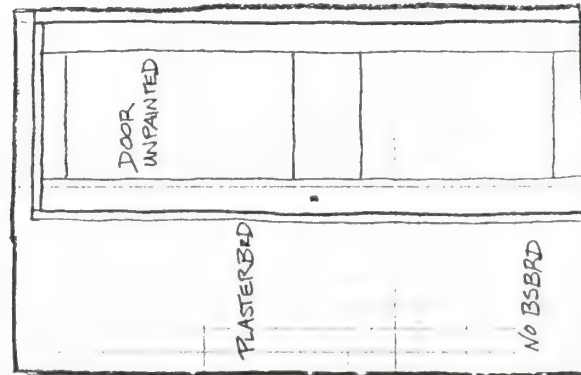
## SOUTH WALLS

DOORWAY: TO RM  
202; MORTISED;  
DOOR WIDENED 2"  
1" EAST SIDE;  
RECESSED PANELS  
RM 204 SIDE;  
RAISED PANELS  
RM 202 SIDE;  
NORFOLK LATCH;  
ARCHITRAVE HAS  
BEAD DETAIL;  
3" HINGES  
OR 1 1/4" SEE RM  
202 FOR DOOR  
DIMENSIONS.

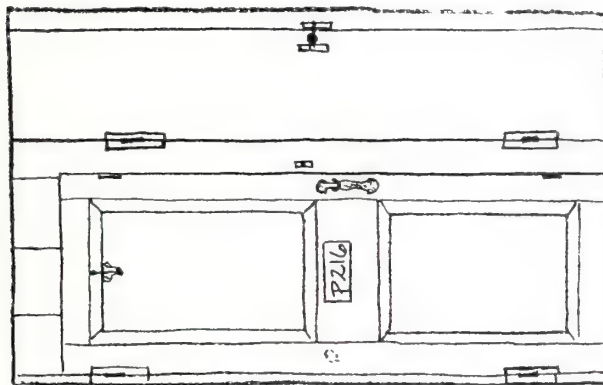
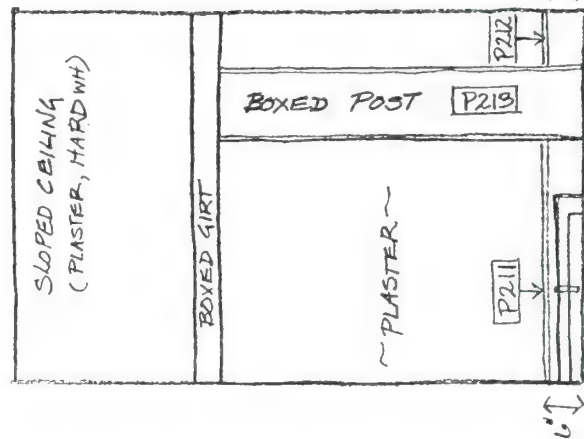
## NORTH WALLS

(RM 204a); MORTISED &  
HAND-PLANED; RAISED &  
MOLDED PANELS RM 204  
SIDE; RECESSED PANELS  
CL SIDE; MORTISES FOR  
2" HINGES EAST SIDE; ALSO  
PATCHED HOLE & FORMER  
LATCH (SUFFOLK) WEST  
SIDE; DOOR MEASURES:  
(ALSO, MODERN  
MAGNET LATCH)  
2' 1 1/4" W  
5' 7 1/2" H  
3/4" THK

EAST DOORWAY: TO BUILT-IN  
IRONING BOARD; DOOR IS A  
SINGLE PLANK OF REUSED  
WOOD, W/ SASH-SANT-MARIS  
ON INT. SIDE & JOIST OR  
STUD SHADOWS; HARDWARE  
IS MODERN; DOOR  
MEASURES: 1 1/2" W  
6' 2 1/4" H  
7/8" THK

FINISHES: CL INT. PTD. WH,  
EXCEPT DOOR THAT IS  
UNPTD. (+ FLOORBOARDS)

NOTE: PAST APPEARS TO BE  
CONTINUOUS TO 1ST FLOOR, AS  
SEEN THRU HOLE IN FLOOR

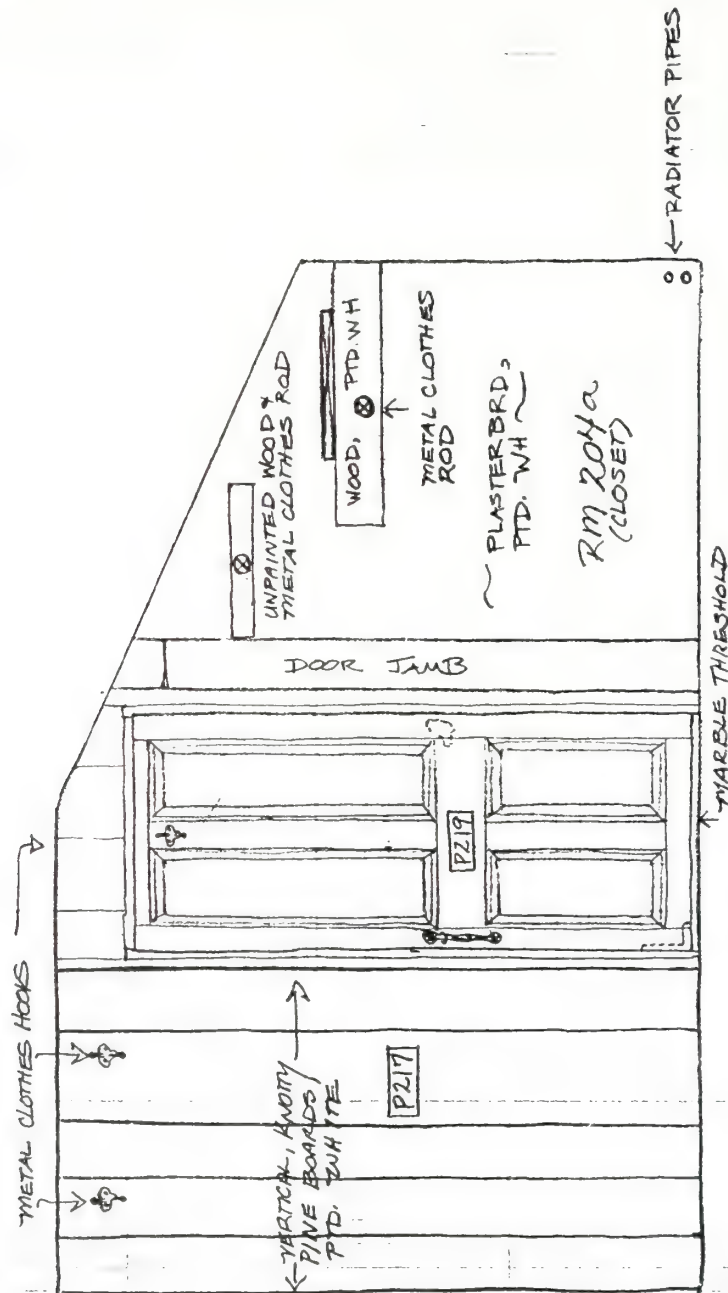
MIMA: MERIATH HS  
RMS 204 & 204a  
WEST WALL  
SEPT. 23, 1993; B. YOCUM

DOORWAY: TO BATHRM; MORTISED;  
RAISED, MOLDED PANELS RM  
204 SIDE (PLAIN RECESSED  
RM 203 SIDE -- SIMILAR TO  
WEST CLOST DOOR, RM 205);  
MODERN SUFFOLK LATCH ~  
CLOTHES HOOK; SHADOW EVIDENCE  
OF FORMER 1/2" HINGE & LATCH;  
SEE RM 203 FOR DOOR  
DIMENSIONS; NO ARCHITRAVE

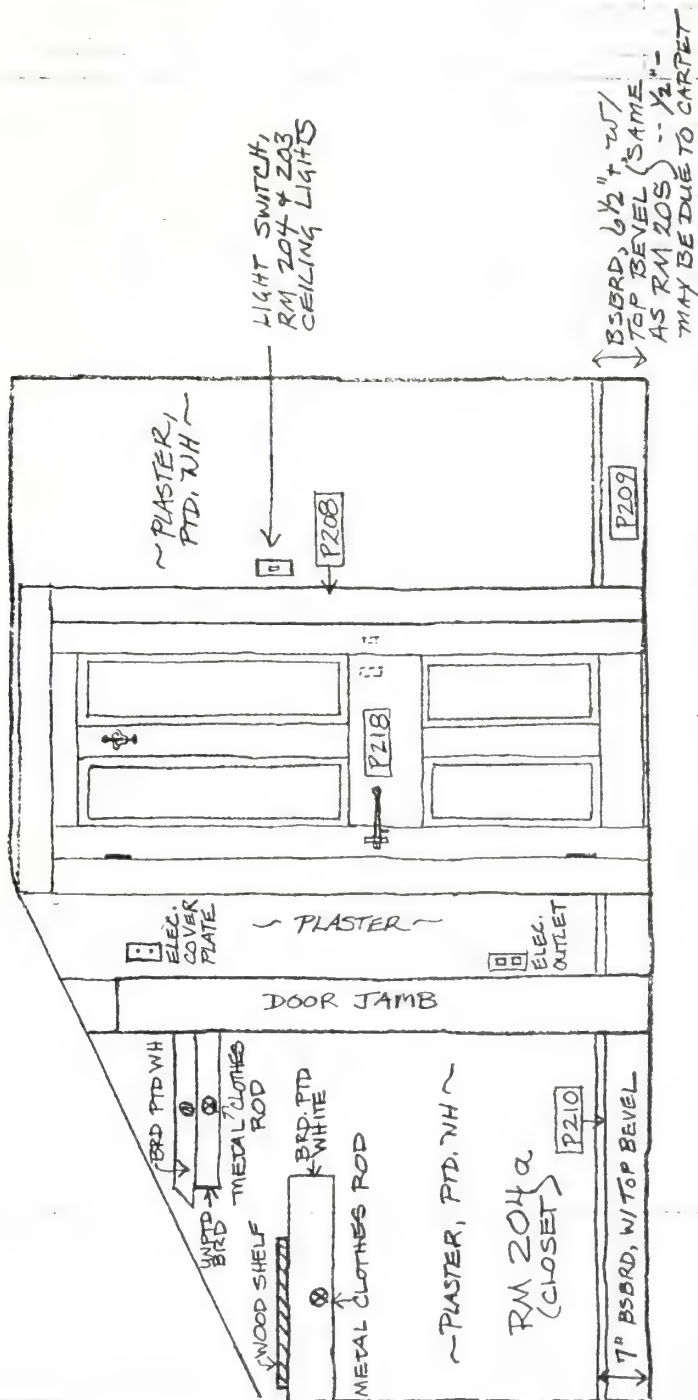
MIMA: MERIAM HS.  
 RMS 204 & 204a  
 EAST WALL  
 SEPT. 23, 1993; B. YOUNG  
 SCALE: 1/2" = 1'0"

DOORWAY: TO RM 205; MODIFIED;  
 RAISED PANELS WITH FLAT  
 BORDERS BOTH SIDES; SHADOW  
 OUTLINE PATCH @ FORMER  
 LATCH LOCATION; 3" RABBETS  
 @ FORMER HINGE LOCATIONS;  
 PLAIN BOARD ARCHITRAVE;  
 SEE RM 205 FOR DOOR  
 DIMENSIONS; METAL CLOTHES  
 HOOK

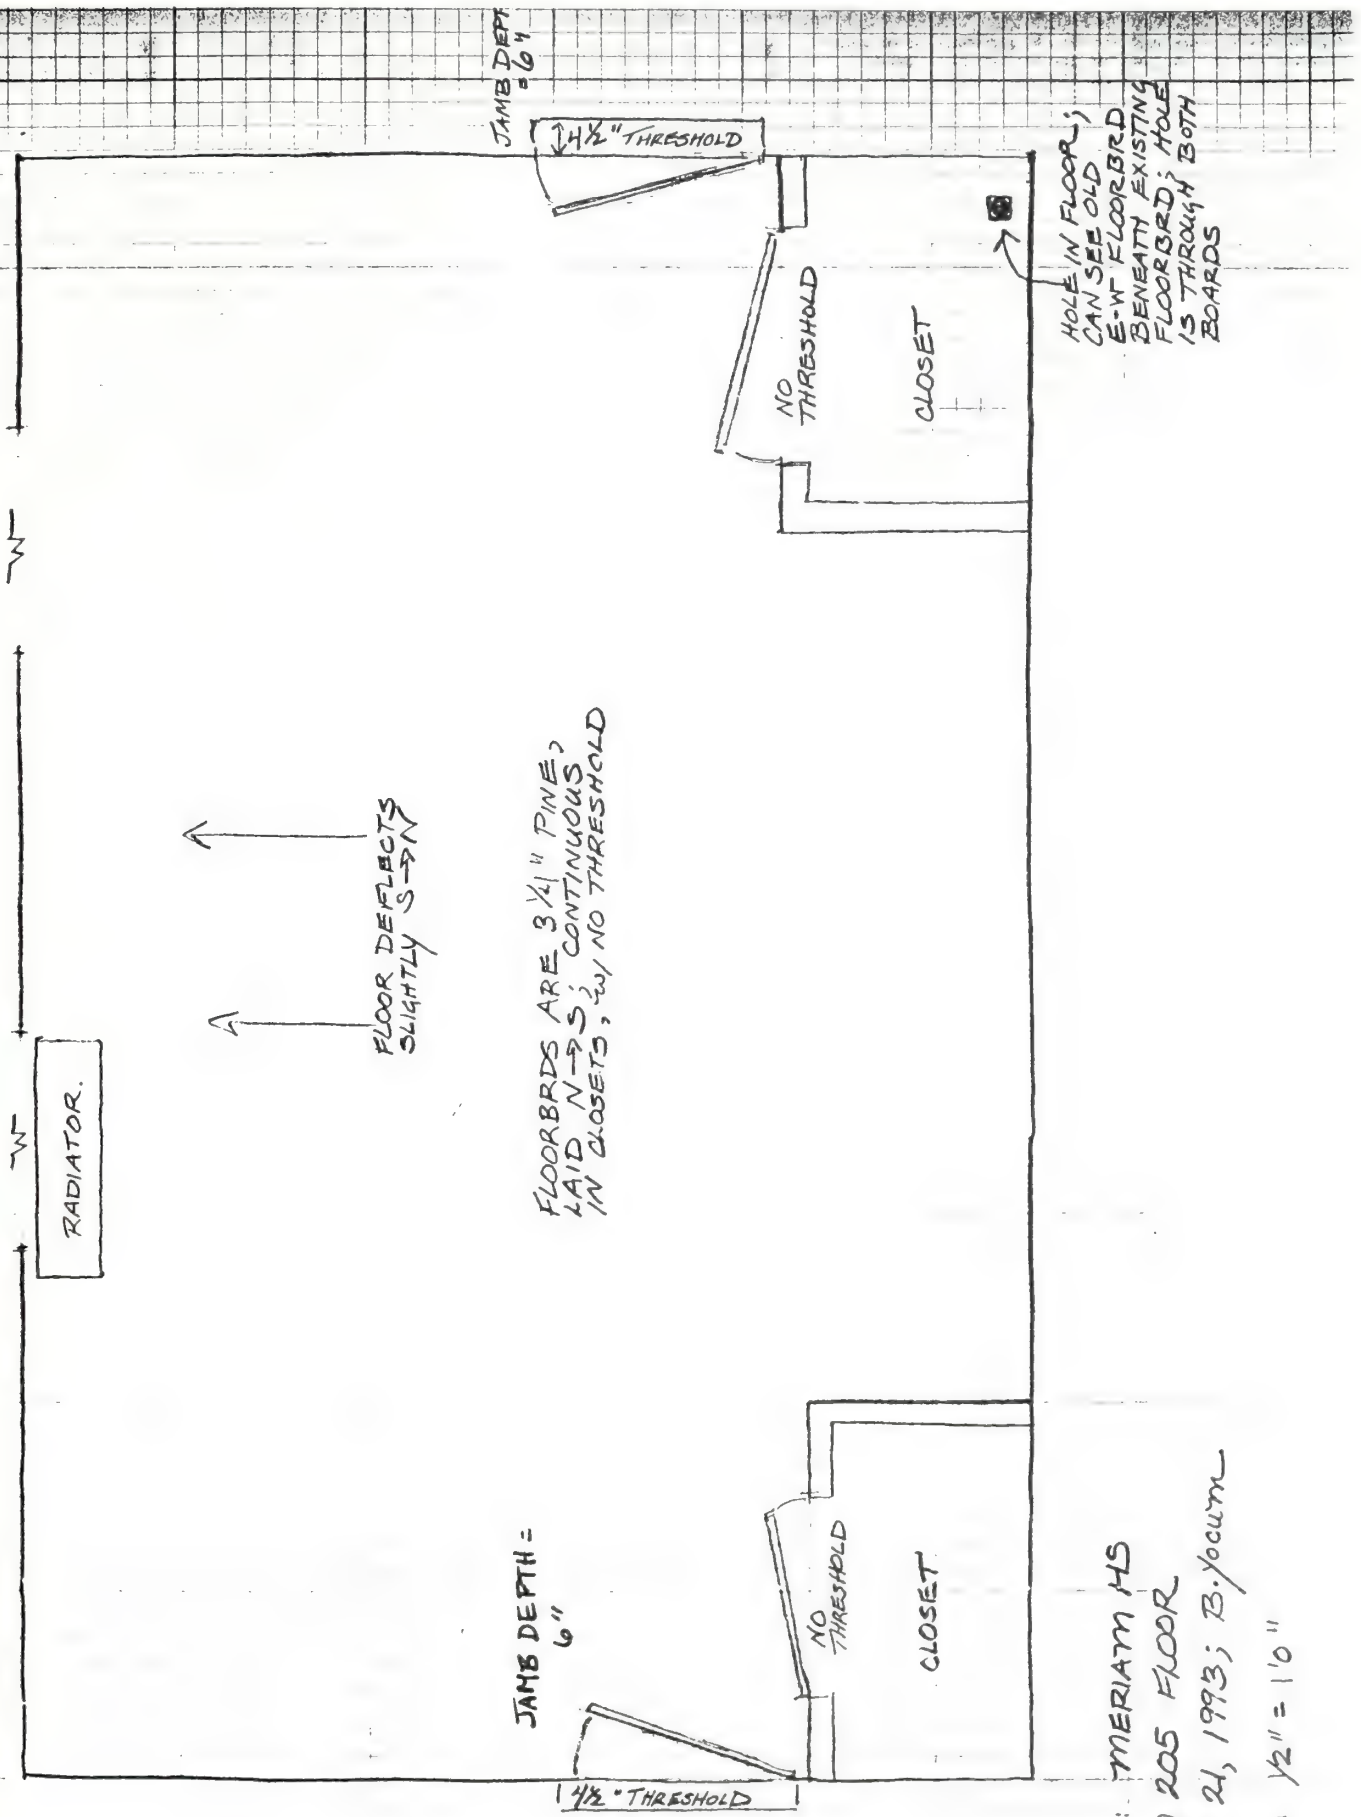
HOLE IN FLOOR;  
CAN SEE OLD  
E-W FLOOR BRD  
BENEATH EXISTING  
FLOOR BRD; HOLE  
IS THROUGH BOTH  
BOARDS

FLOOR BRDS ARE 3 1/4" PINE,  
LAID N-S; CONTINUOUS  
IN CLOSETS, w/ NO THRESHOLD

DOOR STYLE: DITO RM 201. NOTE OUTLINE OF SAME "WAVE" BACKPLATE NORFOLK LATCH UNDER EXISTING LATCH.

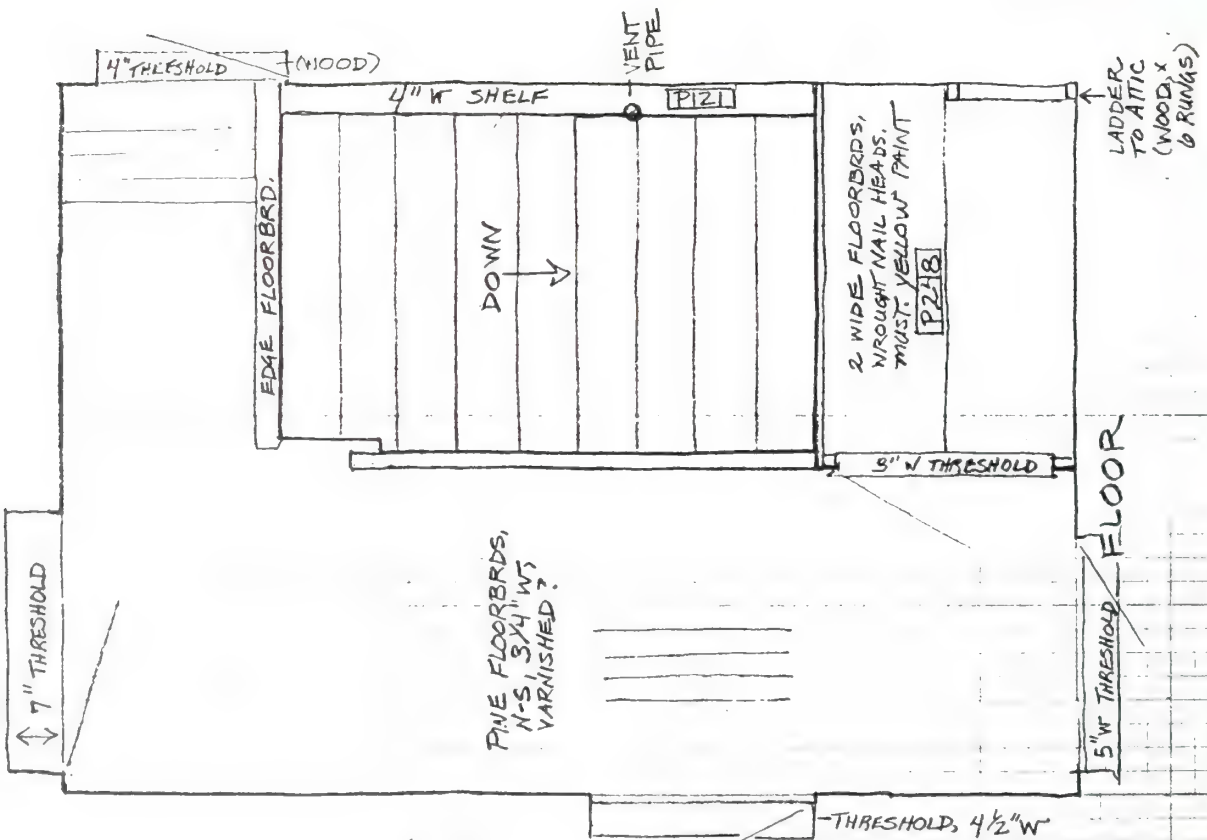
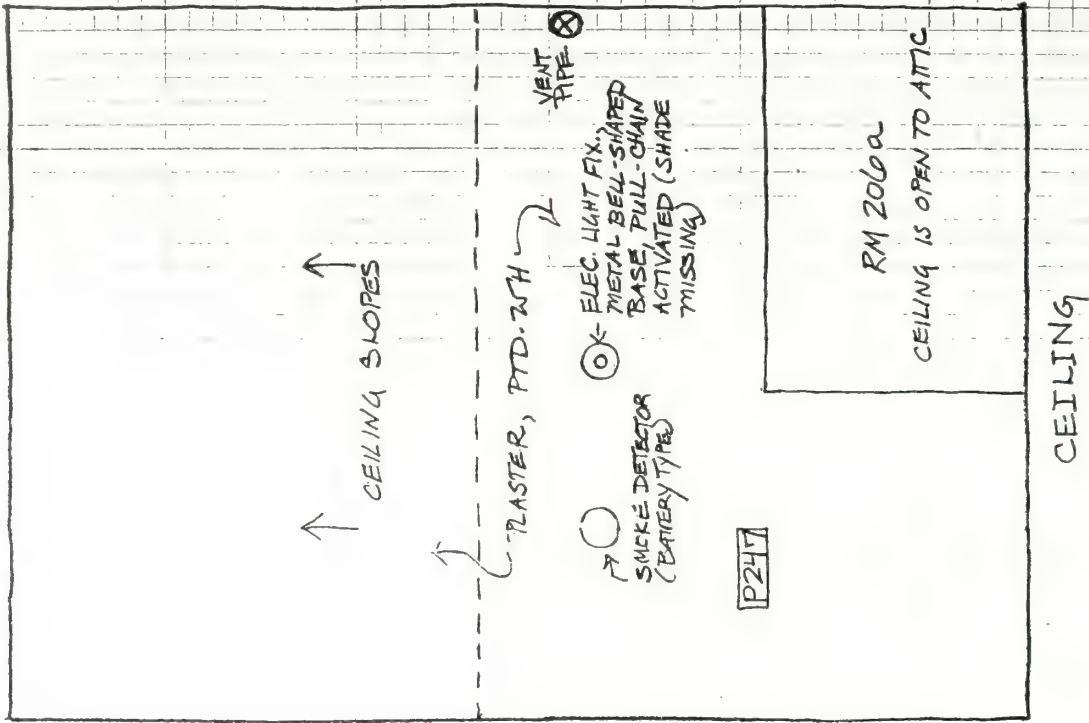
MIMA: MERIAM HS.  
 RM 206, FLOOR + CEILING  
 SEPT 20 1902, 2 V. 114M

DOORWAY: TO RM 207 (SMALL ATTIC); KNOTTY  
PINE BOARDS, MODERN HARWARE; WOOD  
KNOB & SNIVEL LATCH; "Graham"  
WRITTEN IN PENCIL ON EAST JAMB;  
DOOR MEASURES: 2'9 1/2" W  
3'8" H  
1 1/2" THK (2 BRDS)

The back stair hall has one chain-activated light fixture mounted to the ceiling in the center of the room. The fixture has a metal, bell-shaped base and a single bare light bulb; the shade is missing.

A battery-operated smoke detector is mounted to the ceiling, west of the ceiling light fixture. It was installed by the National Park Service. There is no intrusion-protection equipment.

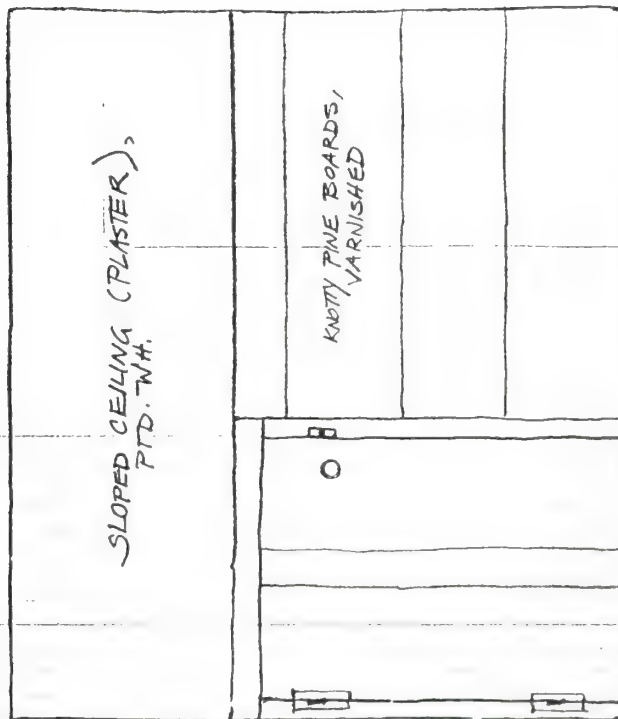
NORTH WALL

THMA: MERIAM HS  
RM 206, NORTH & SOUTH WALLS  
SEPT. 27, 1993; B. Yocum  
SCALE: 1/2" = 1'0"

DOORWAY: TO RM 209; NOT  
MORTISED; MODERN SUFFOLK  
LATCH; METAL CLOTHES  
HOOK; FOR DOOR DIMENSIONS  
SEE RM 209; PLAIN  
BOARD ARCHITRAVE.  
PANELS ARE RAISED ON  
FLAT FIELD & UNMOLDED.

VENT PIPE,  
PTD. WHITE
